## Quarterly Report – Public Page

**Date of Report:** 8th Quarterly Report-September 28, 2020

**Project Title:** River Scour Monitoring System for Pipeline Threat Prevention

**Prepared by:** Dr. Samuel T. Ariaratnam, Arizona State University

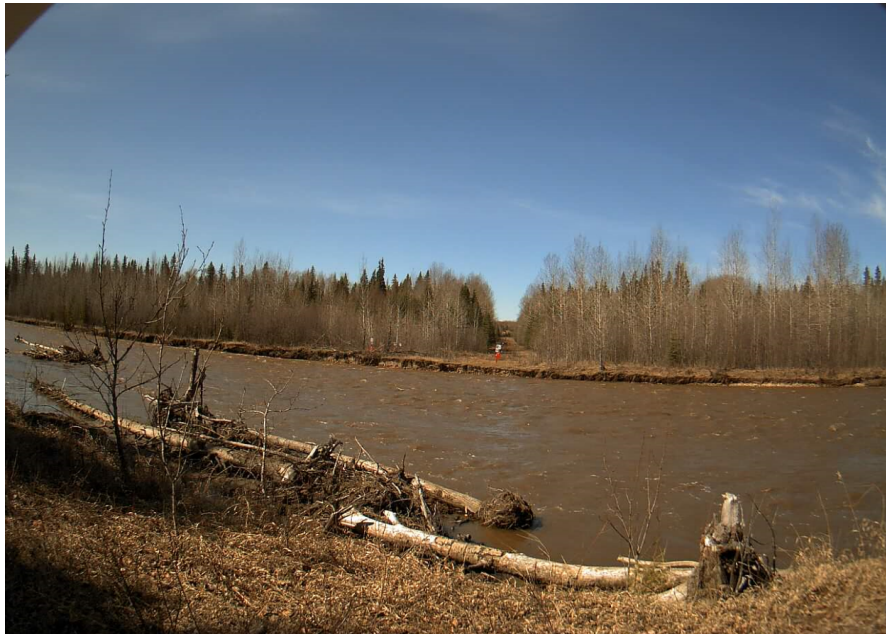
**Figure 7. Freeman River Pipeline Crossing on May 2, 2020**

The Freeman River system was installed March 7-11, 2020 on a 16-inch pipeline owned and operated by Pembina Pipelines under the Freeman River near Fort Assiniboine, Alberta Canada. Three sensors were placed on the pipeline; two upstream and one downstream. The pipeline was exposed and recoated using conventional trenchless pipeline repair methods. The pipeline is currently being monitored for temperature changes. Sample graphs for the pipeline are presented in Figure 6. A camera system was installed in April 2020 to take daily pictures to monitor the river condition throughout the winter melt and subsequent flooding. A picture captured of the crossing from the camera system is shown in Figure 7. In June 2020, after some high river levels, a potential scour was identified during analysis of the data. A crew was mobilized on a survey boat with a high-resolution multi-beam sonar device to map the bottom of the river to verify a pipe exposure as shown in Figure 8. After analysis, it was determined that the pipe area exposed to water was only 0.79 m<sup>2</sup>. This will continue to be monitored over time.

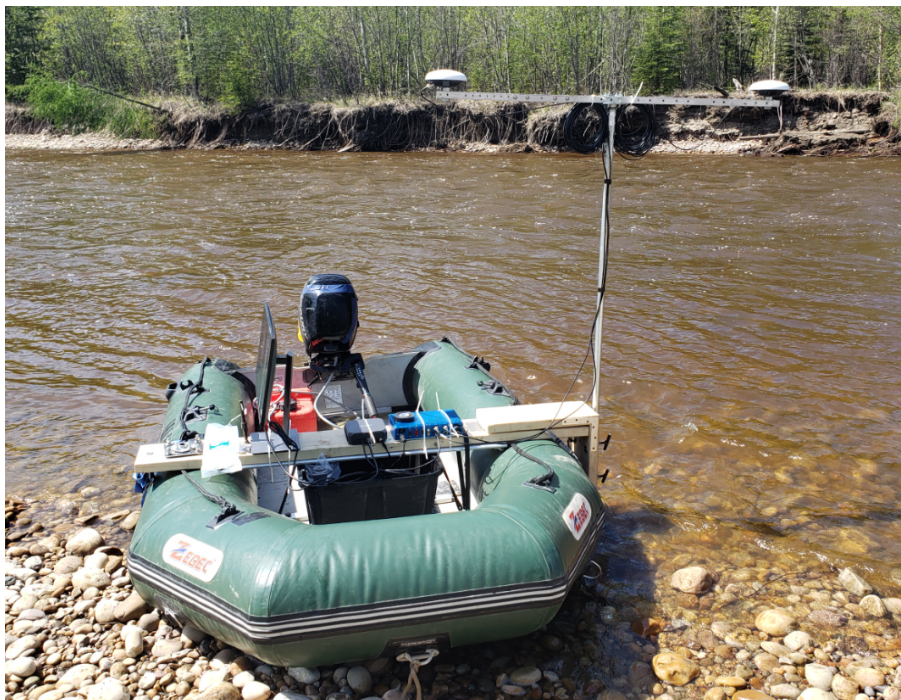
**Figure 8. Survey Boat containing High-Resolution Multi-Beam Sonar**
